Technical Report M9

**ENVIRONMENTAL AND NAVIGATION IMPROVEMENT
STUDY OF WOLF ISLAND
MISSISSIPPI RIVER
MILES 936.5 TO 929**

Prepared For
U.S. Army Corps of Engineers
Mississippi River Valley Division
&
Memphis District

June 2000

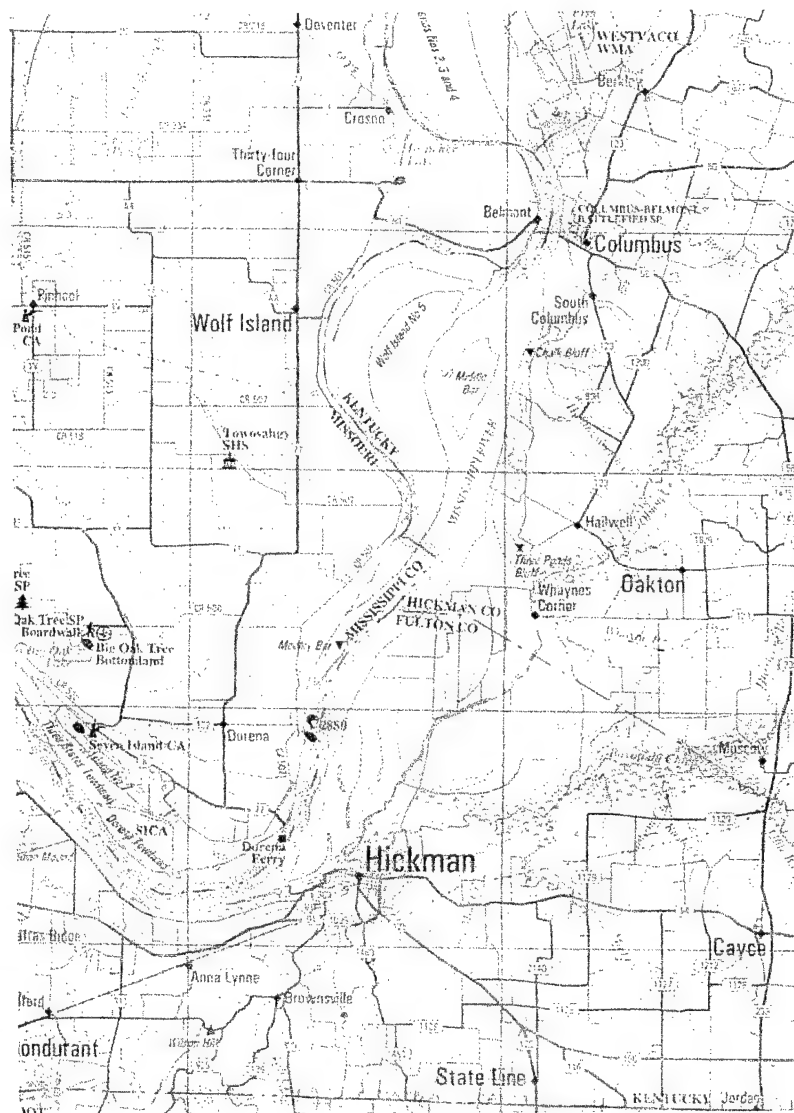
Plate 1 is a map depicting the characteristics, configuration, and nomenclature of the Lower Mississippi River through this particular study reach. The Memphis District constructed both a rock closure dike and longitudinal main channel dike in 1995 in an effort to maintain sufficient channel conveyance in the navigation channel, between Miles 936 and 929. Discharge measurements and flow split calculations were conducted between the period July 1981 through September 1998. Plate 2 is a summary of this data. The data showed that the average flow split over this period of time was approximately 38 percent in the main channel and 62 percent in the side channel. One major concern by Memphis District personnel and the MVD Channel Improvement team was that the relatively large percentage of captured flow in the secondary side channel (greater than 60 % at stages between 30 and 40 ft.) was encouraging the development of a future, permanent cutoff from the main channel. If this event were to occur, a tremendous amount of future dredging and channel improvement works would be required in order to maintain a new navigation channel.

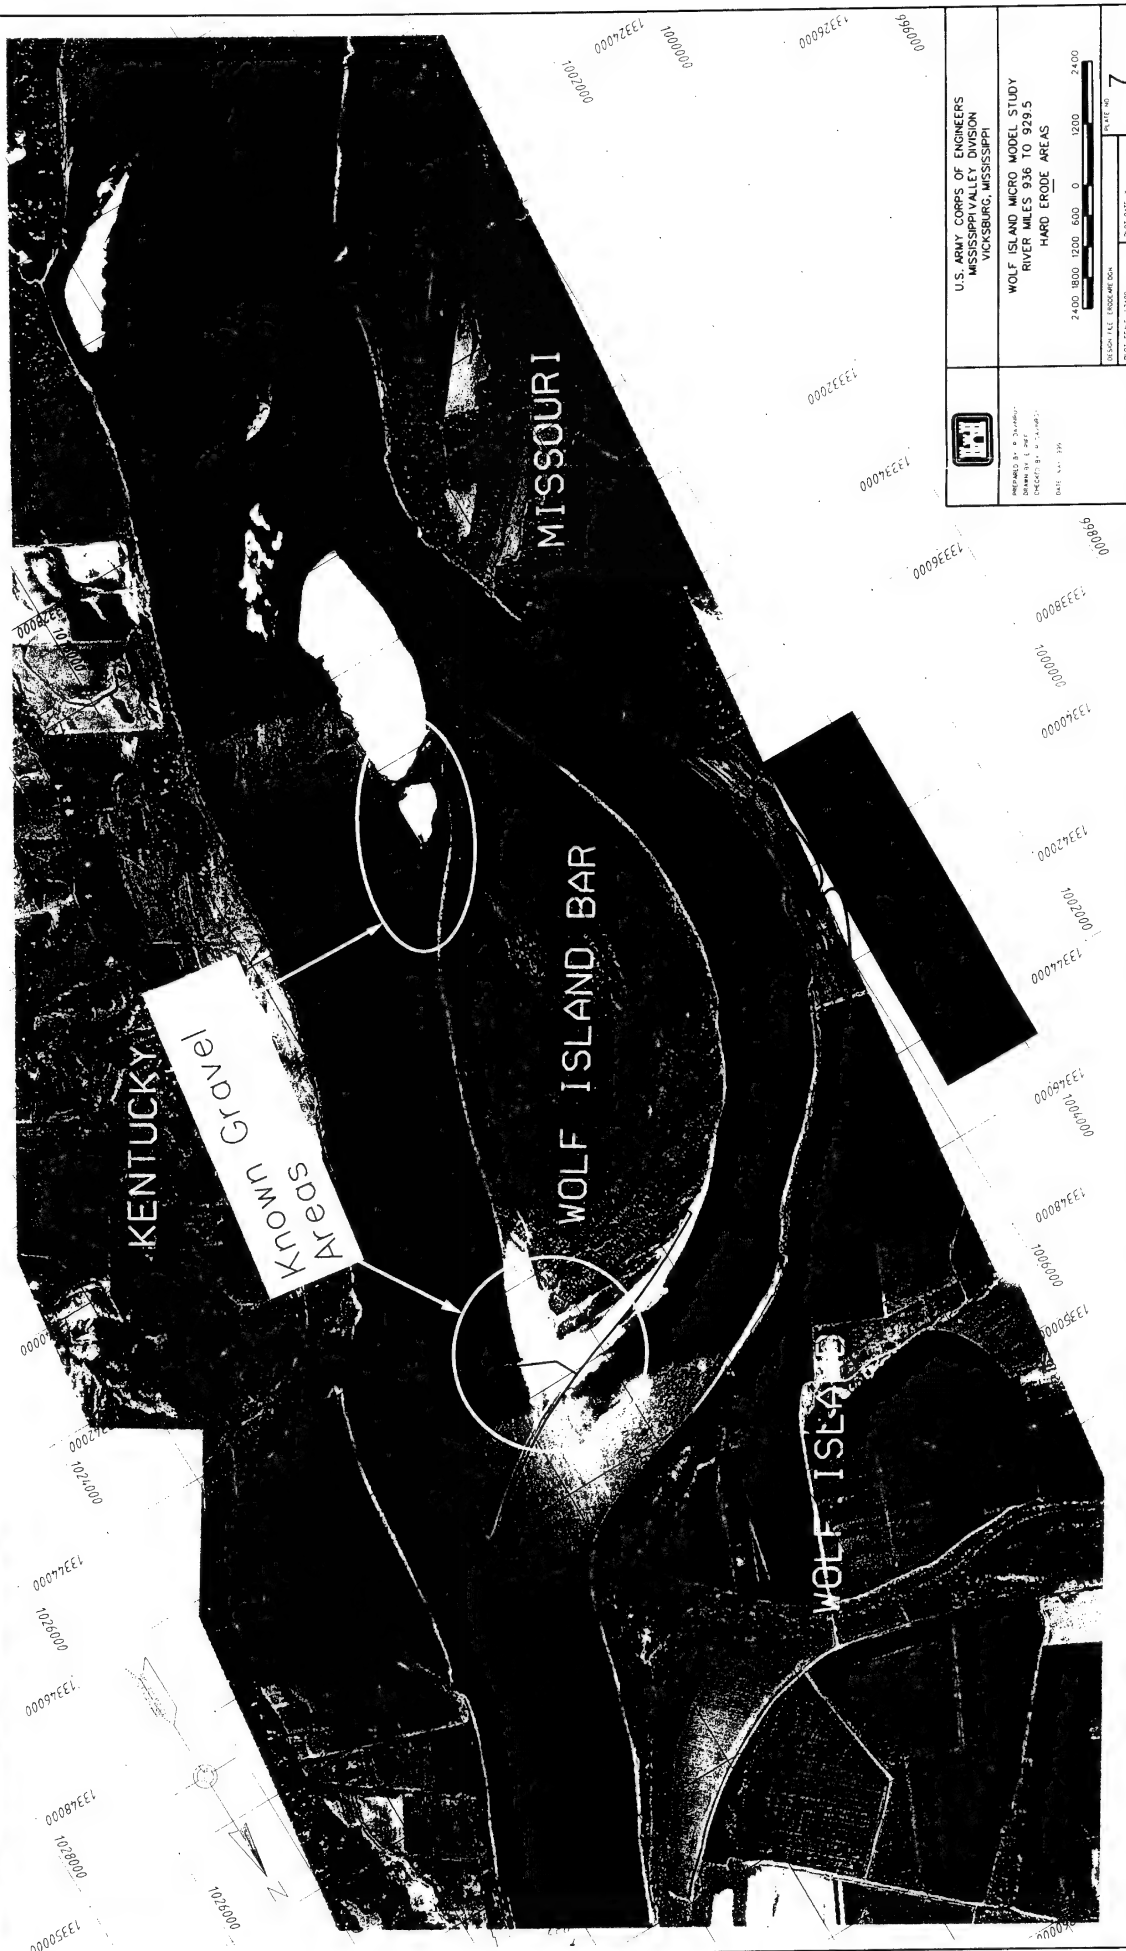
"Hard Erode" Areas

U.S. ARMY CORPS OF ENGINEERS MISSISSIPPI DIVISION VICKSBURG, MISSISSIPPI
	WOLF ISLAND MICRO MODEL STUDY RIVER MILES 936 TO 929.5 HARD ERODE AREAS
2400 1800 1200 600 0 1200 2400 FEET SCALE (ENGLISH) METERS 2400 1800 1200 600 0 1200 2400 METERS SCALE (METRIC)	
SHEET NO. 7 OF 7

Of vital importance to the calibration of the model was the knowledge of possible non-erosive areas within the study reach. In 1990, a field inspection by MVD engineers revealed that an abundant amount of conglomerated cobbles, gravel, and coarse sand existed throughout the surrounding bar of Wolf Island adjacent to the main channel, as discussed previously. The combined effect of armoring was apparent. Morphology conducted by Fisk revealed that this entire area at one time was inhabited by the Ohio River, thus explaining the existence of the relatively larger, coarser material (Rentschler 1999).

As a result, the bar in the model in the vicinity of the field inspection, off the left descending bank between Miles 935.5 and 934.5, was molded out of clay.

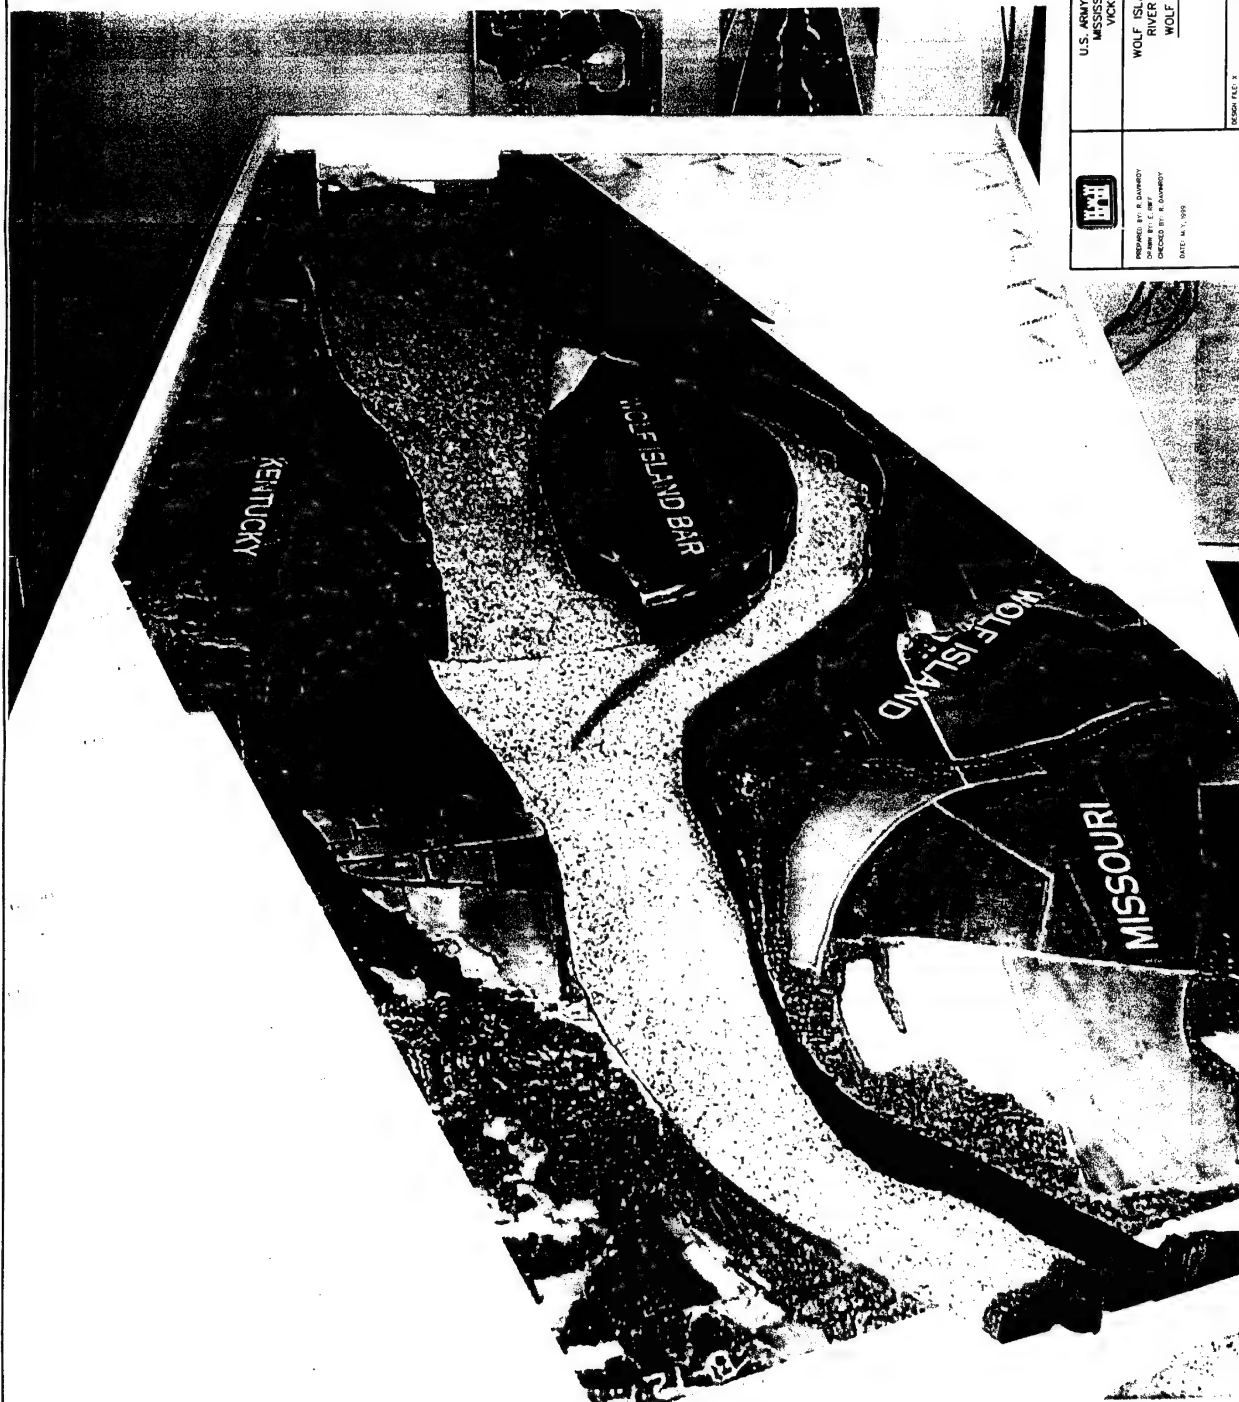
U.S. ARMY CORPS OF ENGINEERS
 MISSISSIPPI VALLEY DIVISION
 VICKSBURG, MISSISSIPPI
 WOLF ISLAND MICRO MODEL STUDY
 RIVER MILES 936 TO 929.5
 WOLF ISLAND MICRO MODEL
 DESIGN FILE NO.
 PLOT DATE: X
 PLOT SCALE:
 PLATE NO. 8

Plate 8 is a photograph of the Wolf Island hydraulic micro model used in this study. The scales were 1 inch = 600 feet, or 1:7200 horizontal, 1 inch = 50 feet, or 1:600 vertically, for a 12:1 distortion ratio. This distortion supplied the necessary forces required for the simulation of sediment transport conditions similar to the prototype. The bed material was granular plastic urea, Type II, with a specific gravity of 1.23.

The model was constructed according to detailed aerial photographs of the Mississippi River. Flow was controlled via an electronic/computer interface and mechanical control valve. Stages and resultant bed configurations were surveyed with a 3-dimensional laser scanner. Structures were set with a three-dimensional digitizer. Slope was controlled by rotational jacks located within the hydraulic flume.

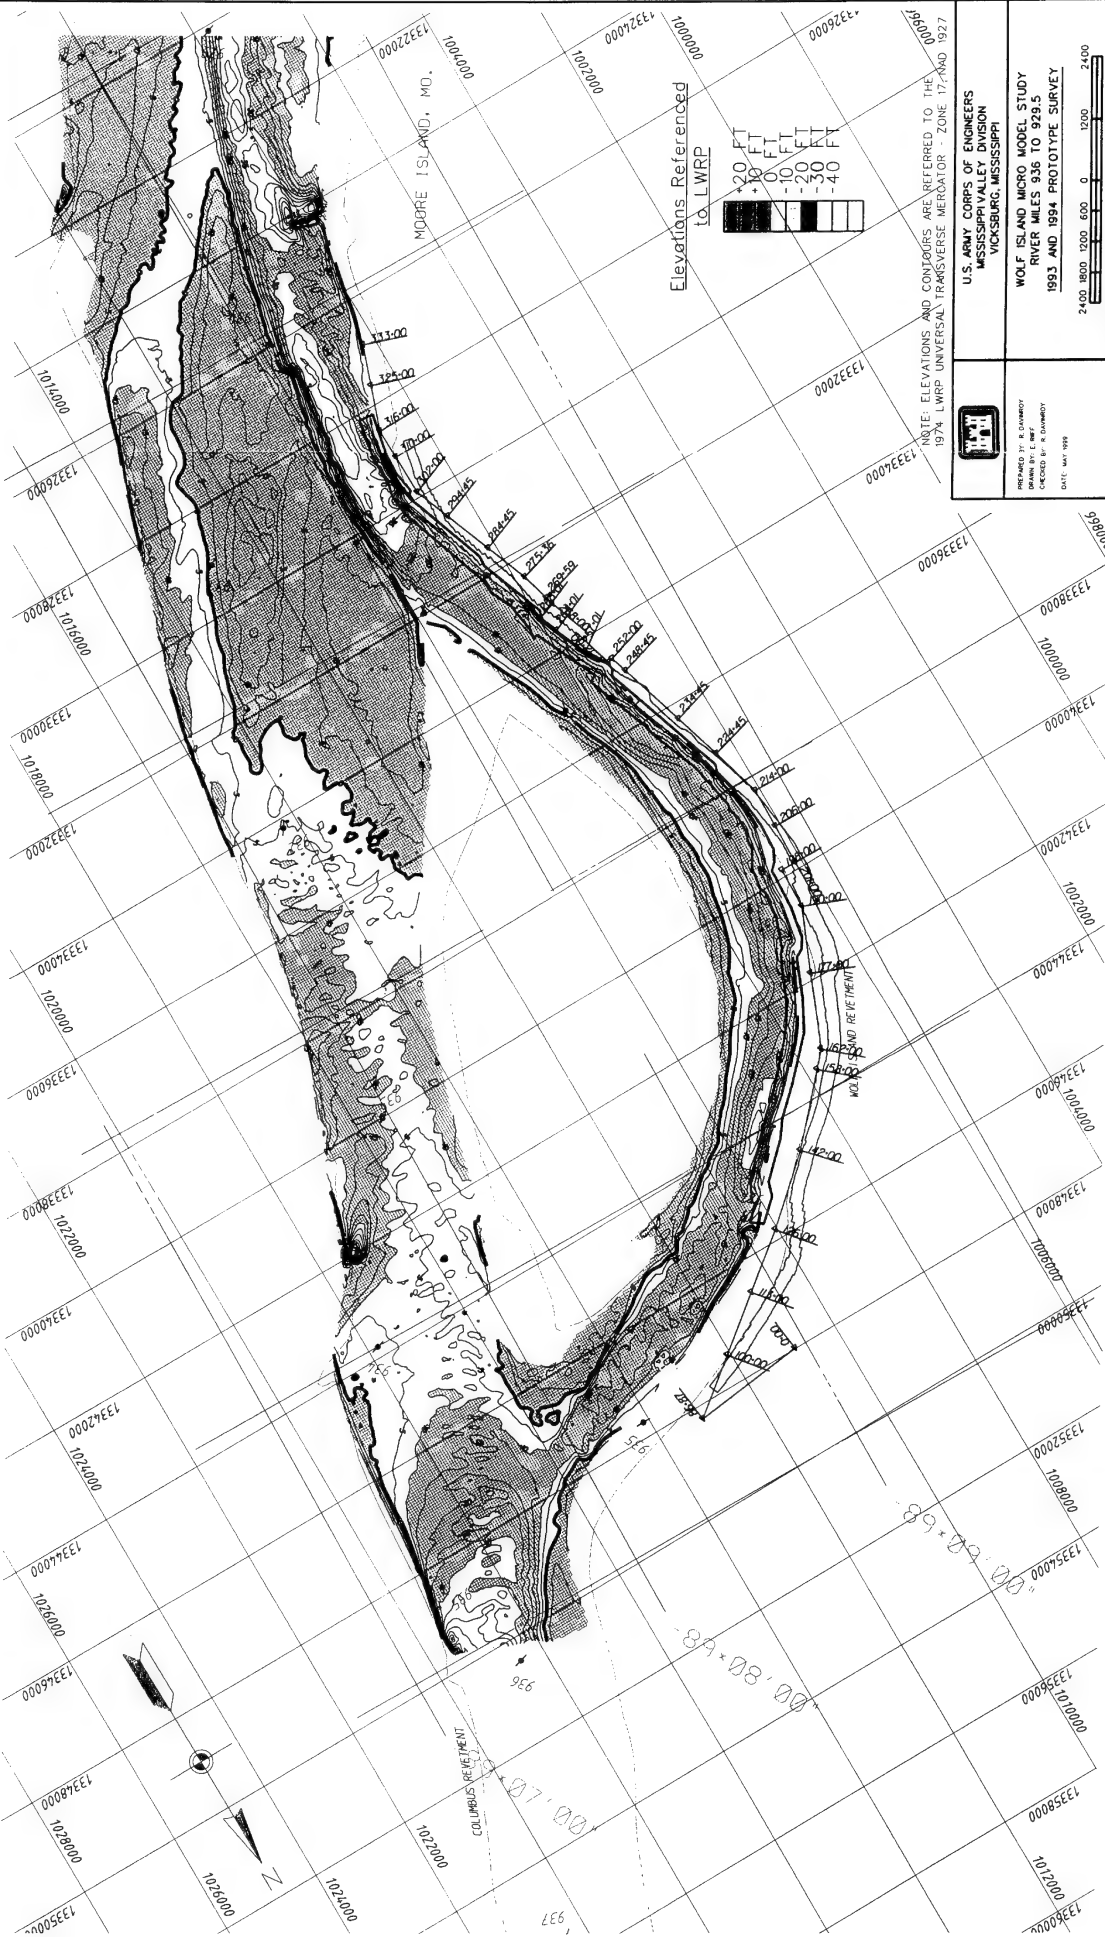
Another concern was that an extremely difficult navigation alignment had developed in the main channel between Miles 936 and 935. A channel sweep hydrographic survey collected in the study reach in November 1993 and March

1994 (Plate 9) showed the navigation channel and the channel thalweg along Columbus Revetment (left descending bank), near Mile 936, made a sharp, 90 degree turn toward the right descending bank along Wolf Island Revetment. The main channel had become excessively narrow at Mile 935. Downbound tows were having a difficult and dangerous time transiting through this area. Currents at Mile 936 off the left descending bank were such that tows were being forced toward the Wolf Island side channel away from the main channel.

Several prototype surveys (1993/94, 1996, 1997, and 1998) were used to determine the general bed characteristics that have existed in the prototype over the years (Plates 9 through 14). Generally, only slight trend change differences were observed between the surveys from pre and post construction of the closing structure and longitudinal dike at the upper end of Wolf Island Chute. In the earliest 1993/94 survey, taken prior to construction, the bathymetric trends

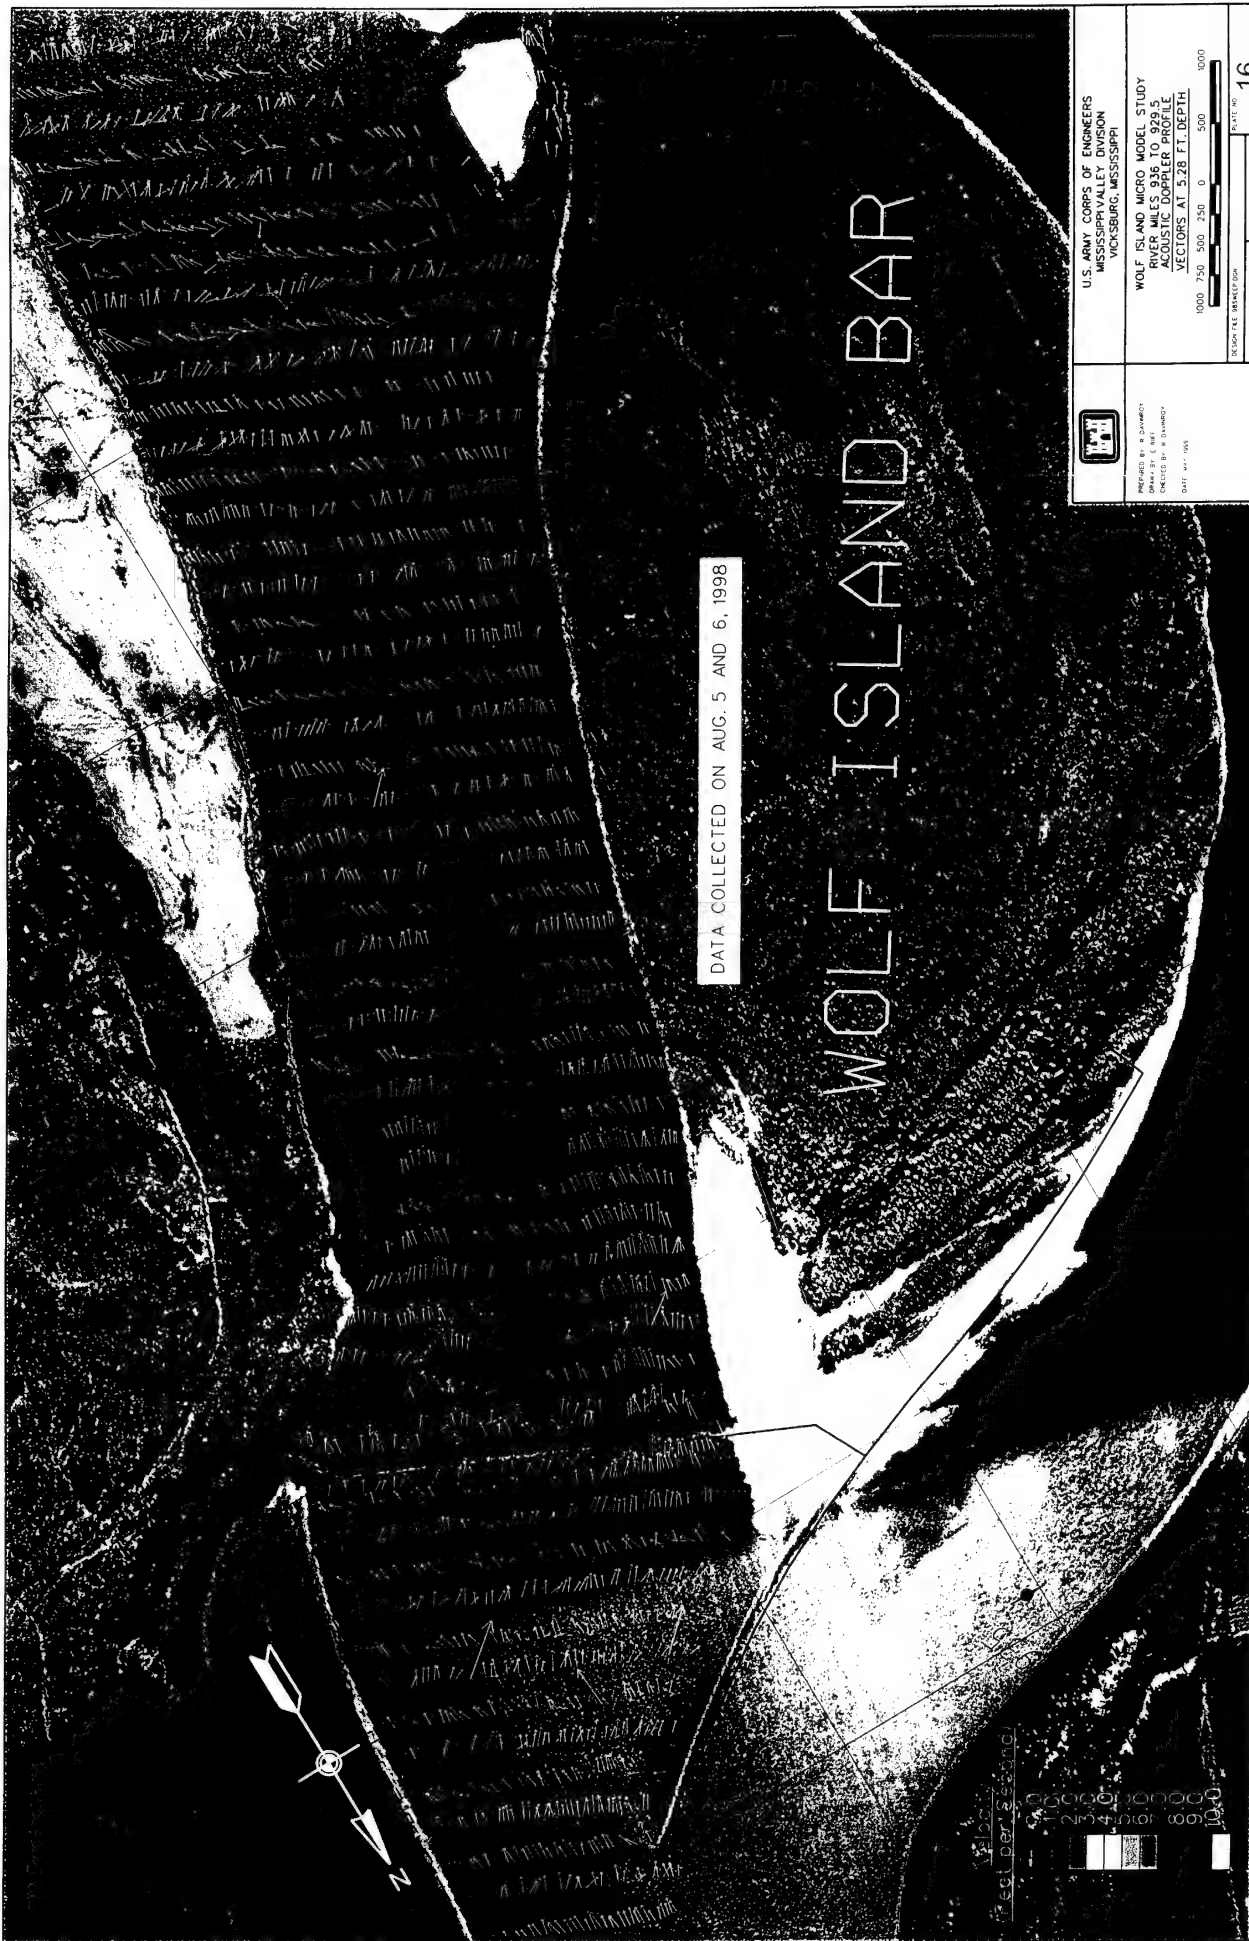
In 1998, velocities were generally similar through both the right and left notches. Associated flow through the side channel seemed to be evenly distributed down the two channels below the notches. Near Mile 932, there was a considerable

amount of erroneous data that did not clearly define the proper direction of the velocities.

U.S. ARMY CORPS OF ENGINEERS MISSISSIPPI VALLEY DIVISION VICKSBURG, MISSISSIPPI
	WOLF ISLAND MICRO MODEL STUDY RIVER MILES 936 TO 929.5 ACOUSTIC DOPPLER PROFILE VECTORS AT 5.28 FT. DEPTH
1000 750 500 250 0 500 1000	
FOOT SCALE 1:1000	
DATE MAY 1998	
PAGE NO. 16

Plates 15 and 16 are plan view velocity vectors maps generated from Acoustic Doppler Current Profile (ADCP) data, obtained in the Mississippi River in 1996 and 1998, respectfully. Velocity data was extracted from profile information and plotted as plan view directional vectors at a depth of 5.28 feet. Results indicated the following:

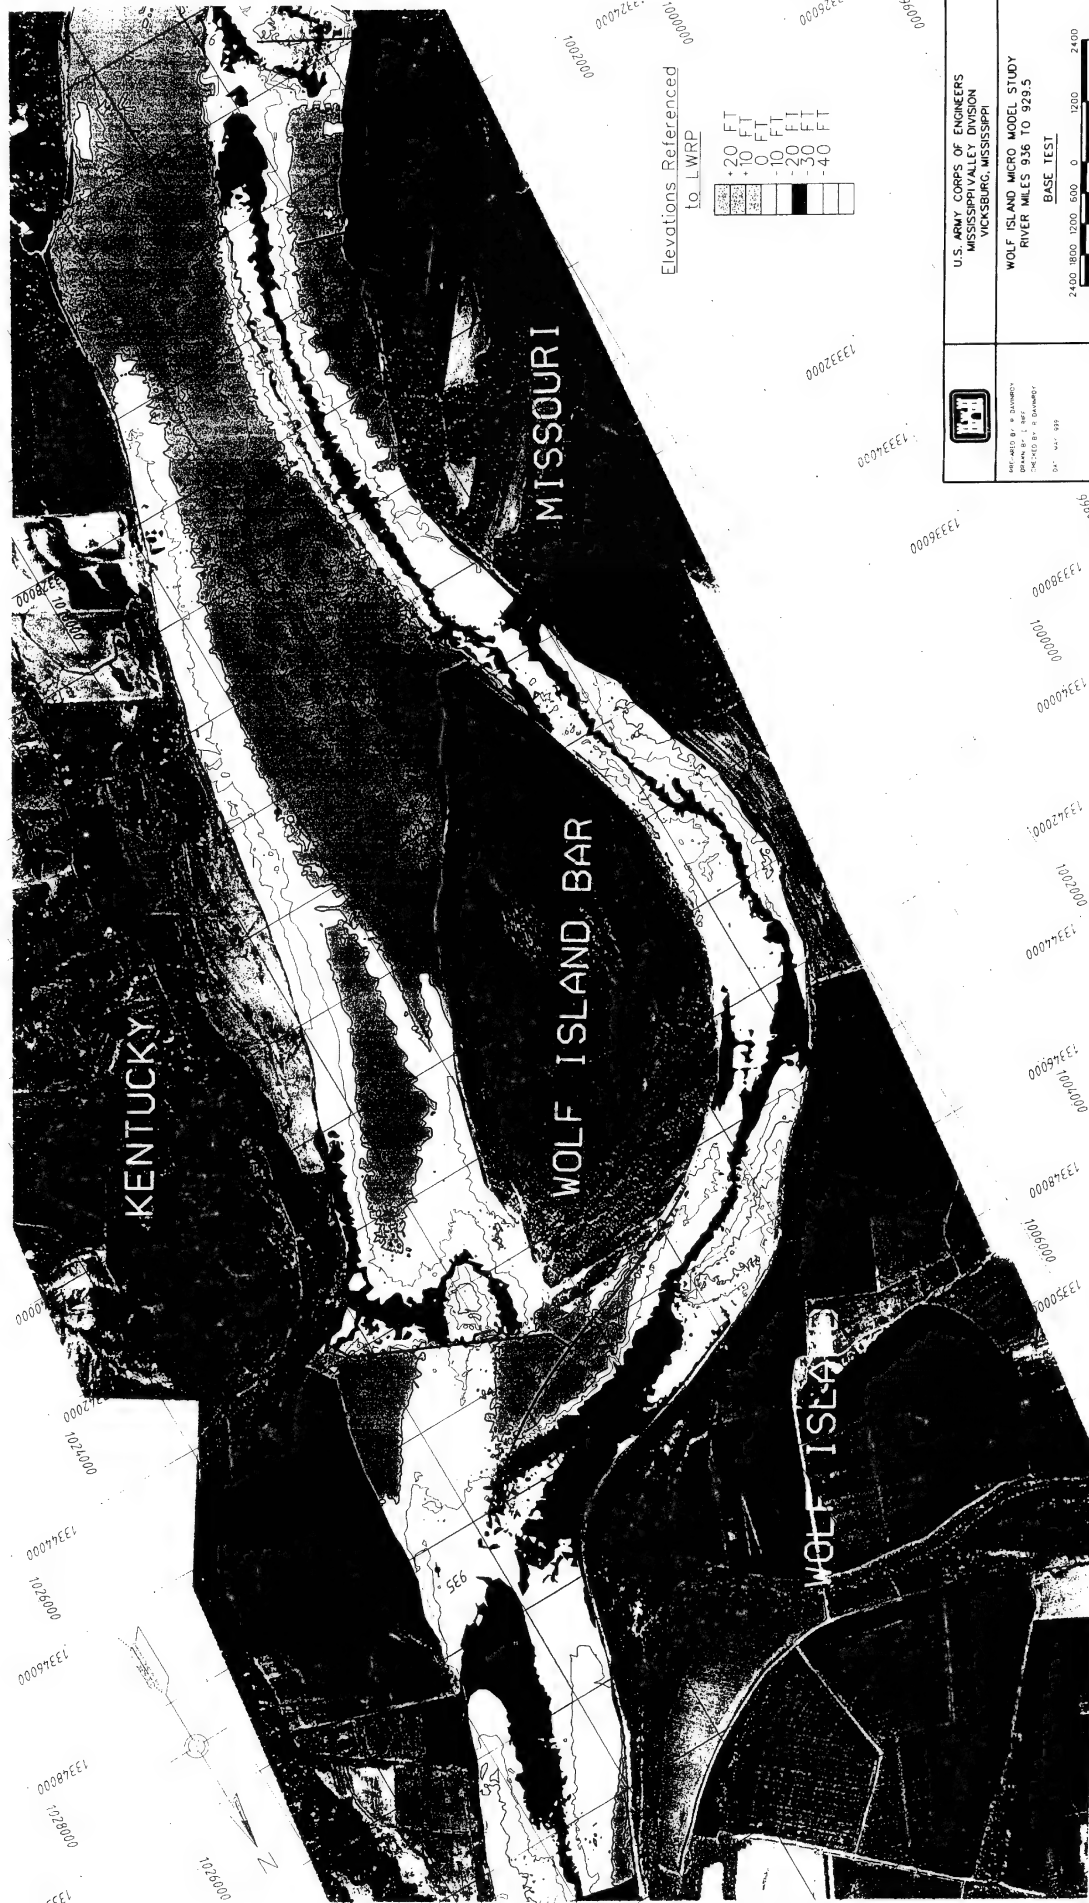
Plate 17 shows the resultant bed configuration of the micro model base test. The base test was developed from the simulation of successive design hydrographs until bed stability was reached and a similar bed response was achieved as compared with the prototype surveys. Results of the base test and comparison to the prototype indicated the following trends:

Entrance conditions of the model began at approximately Mile 937.5. At Mile 936.5, off the left descending bank at Columbus Revetment, the thalweg developed in the model, with depths between -30 feet and -50 feet LWRP. This

scour hole pattern followed the general trend of the prototype surveys, although in the prototype the scour hole extended approximately 0.5 miles further downstream to Mile 935.8. Between Mile 935.8 and 934.2, a crossing developed in the model, with depths between -10 feet and -20 feet LWRP. Between Mile 935.8 and Mile 935.5, the shallowest area of the crossing developed, with depths near -10 feet LWRP. This same shoaling trend was evident in the prototype surveys.

From Mile 935 to 932, the thalweg developed against the right descending bank. Depths through this segment of the model ranged between -20 feet and -60 feet LWRP. Depths in the prototype were generally less, between -20 feet and -30 feet LWRP. Between Mile 932 and 931, a crossing developed in both the model and the prototype. Depths in the model were slightly shallower than the prototype. Between Mile 932 and the exit conditions of the model, the channel was located against the left descending bank, with depths in both the model and the prototype between -30 feet to -40 feet LWRP.

The general upstream approach trends of the side channel were very similar between the model and prototype. Depths in the model were higher than the prototype by 0 to 10 feet, but the relative distribution pattern of the sediment was very similar. A bar formation was established off the left descending bank directly above the closure and extended approximately 2000 feet in breadth across the channel. Beyond this point, a shallower approach channel to the right closure notch was defined in both the model and the prototype.

At the closure structure, since direct elevations defining centerline depths of the two notches were impossible to obtain in the field because of the dangerous velocity conditions that existed, the invert of the notches in the model were calibrated by trial and error. In order for downstream sediment trends in the model to develop similar to the prototype, the left notch was completely shut off, while the right notch was degraded to -14 feet LWRP. During the calibration, it

was observed that the right notch was the dominant notch carrying the majority of the bed load through the side channel. Enabling the left notch to dominate during calibration as an experiment caused major deposition in the side channel along the left descending bank.

Downstream of the closure structure, between Mile 934.1 and 932, trends in both the model and the prototype were similar. Below the left notch, scour hole depths between -20 feet and -30 feet LWRP developed against the left descending bank similar to what was observed in the prototype surveys. A left channel extended along the left descending to approximately Mile 932. Between 932 and 931.8, there was a tendency for shoaling in this channel. Between 931.8 and 930.8, this channel was redefined, similar to what was observed in the prototype.

Below the right notch, a scour hole with depths between -50 feet and -60 feet LWRP developed in the model similar to the prototype. Flow below the notch deflected off the right descending bank, near Mile 933.5, and then crossed over to join the channel off the left descending bank, near Mile 932.5.

Between the left and right notches, the 20 foot scour depth that formed directly below the closure structure extended somewhat farther downstream in the model than the prototype. The hydrographic surveys and bathymetry obtained from the multi-swath indicated that this localized downstream scour in this area was a periodic trend tendency. In some particular years, deposition apparently builds up directly downstream against the structure.

Against the right descending bank of the side channel between Mile 933.6 and 933.1, a channel formed in the model to depths near -10 feet LWRP.

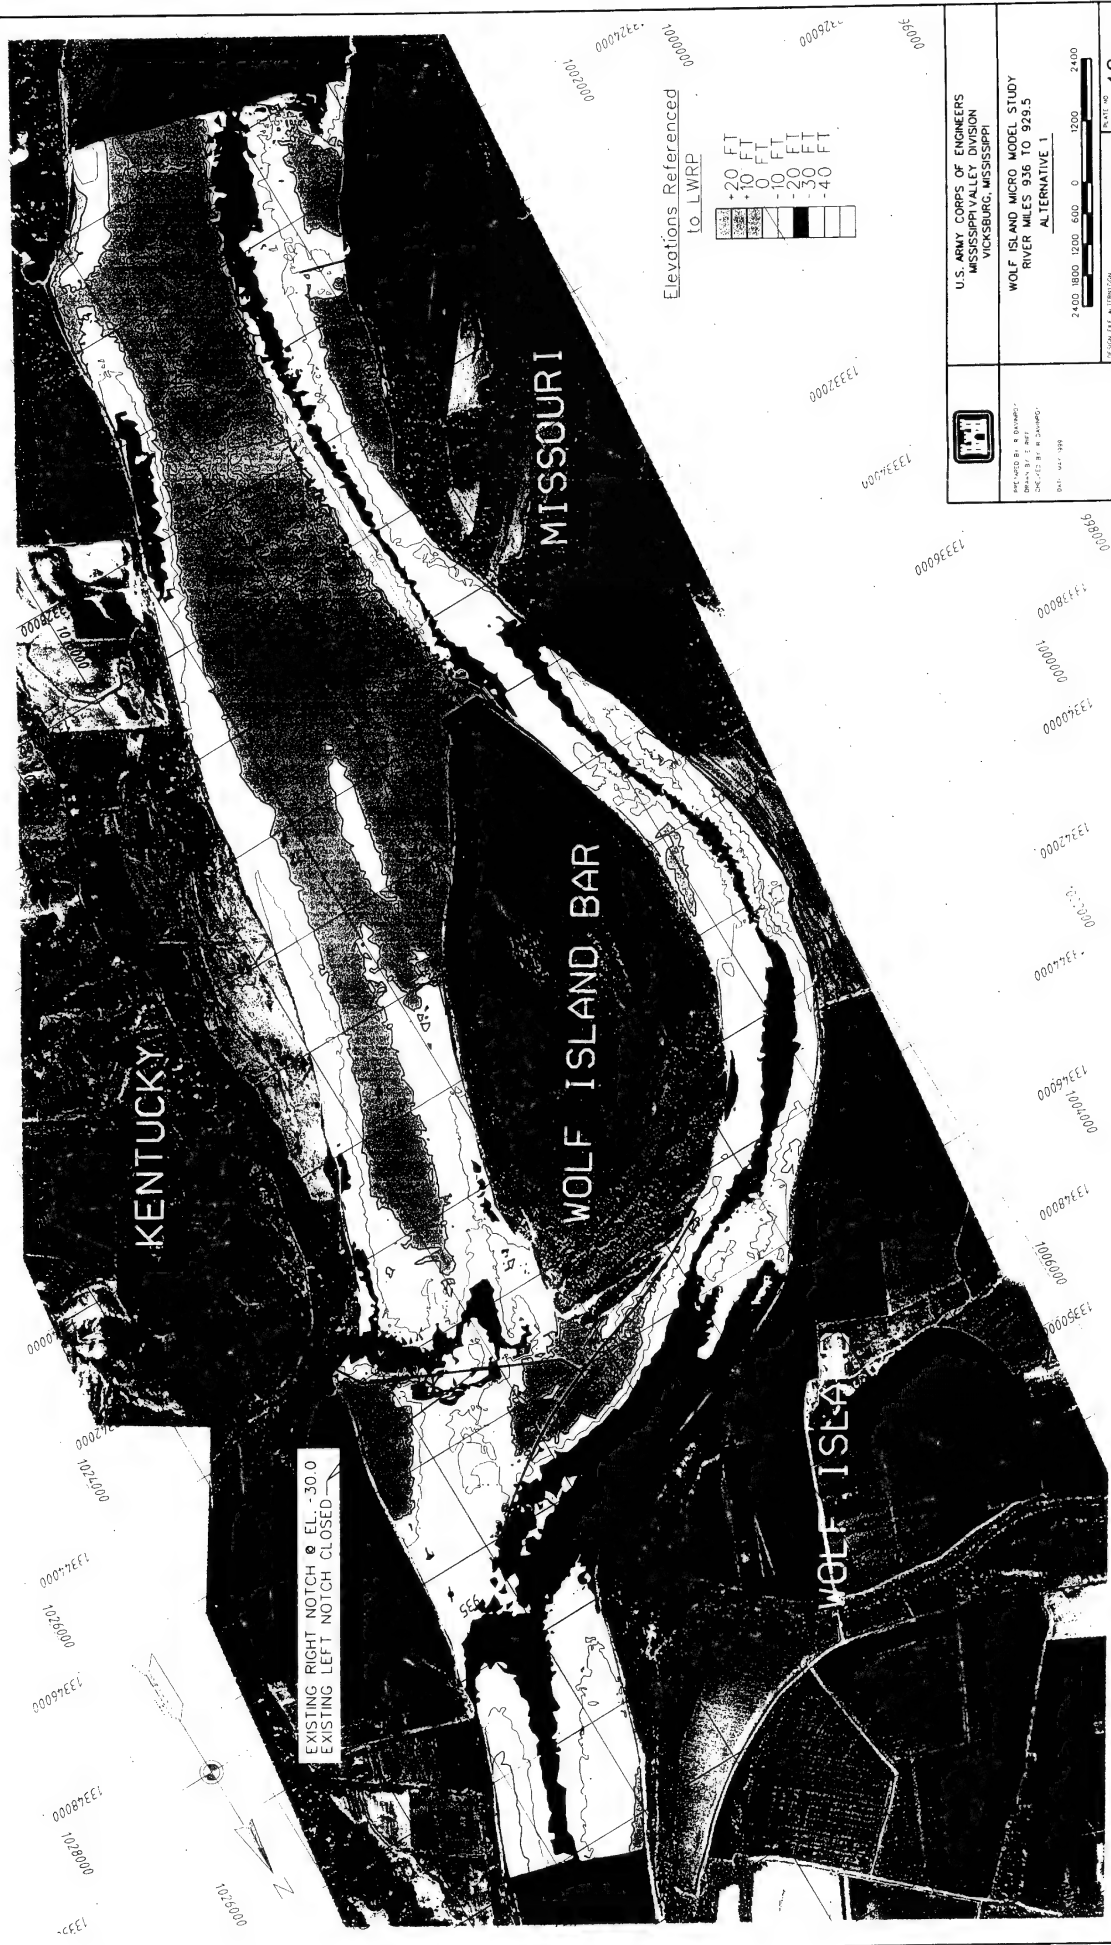
Closed. Plate 18 shows the resultant bed configuration of Alternative 1. Test results indicated the following observed trends:

Depths increased just upstream of the closure structure approaching the right notch between 0 and 5 feet. A scour hole developed upstream of the closure in front of the right notch due to the increase of flow through the notch. The scour hole downstream of the right notch decreased approximately 10 feet in depth. The overall effect of the degradation of the right notch in the vicinity of the closure structure was an increase in approach depth and a slight decrease in exit depths.

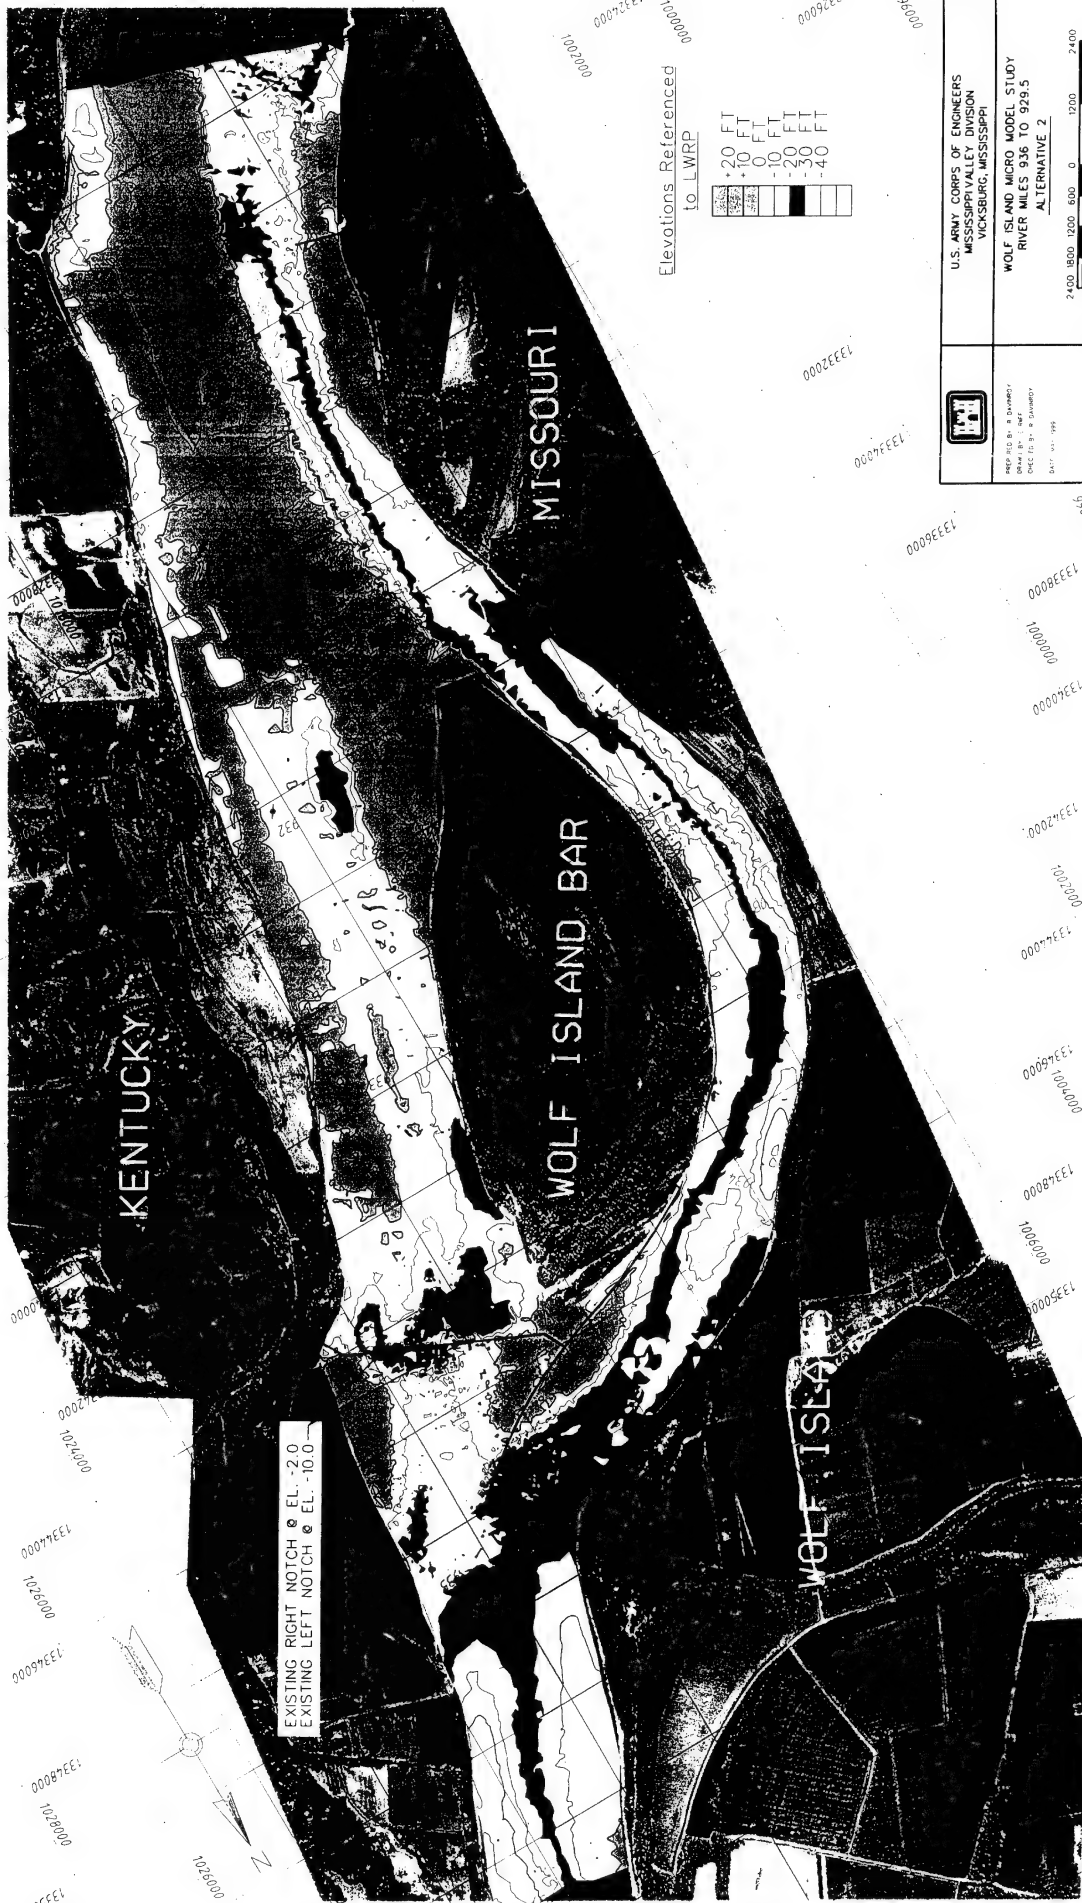
WOLF ISLAND MICRO MODEL STUDY
RIVER MILES 936 TO 929.5
ALTERNATIVE 2

Alternative 2. Closure Structure Right Notch at -2 feet LWRP and Left Notch at -10 feet LWRP. Plate 19 shows the resultant bed configuration of Alternative 1. Test results indicated the following observed trends:

In the main channel, at the upper end of the model, scour developed along the left descending bank, to depths between -50 feet and -60 feet LWRP, against Columbus Revetment similar to the base test. The crossing at Mile 935.5 deepened slightly, with depths near -20 feet LWRP. From Mile 934 to the end of the model, the trends were essentially the same as observed in the base test.

Within the side channel, scour developed directly below the left notch, with depths near -30 feet LWRP. More flow and sediment were observed moving through the notch as compared to the base test. Between Miles 933 and 931.5, the channel along the left descending bank filled with sediment as a result of this increased load, to depths between 0 and +10 feet LWRP. Once the high bar formed, along the left descending bank, more flow was then forced against the right descending high bar, and a large scour hole developed near Mile 932. A new channel was thus formed, with depths between -20 feet and -30 feet LWRP.

- All closure structure alternatives showed that the relationship between the two notches was sensitive and inter-dependent. The left notch, when compromised, had a tendency to dominate the transport of sediment within the side channel. The more the left notch dominated, the more flow and sediment was distributed through this notch and the more the tendency for the channel along the left descending bank to fill in with sediment. This depositional trend below the left notch ultimately caused a new channel to develop further downstream on the opposite side of the side channel, against the right descending lower high bar of Wolf Island, near Mile 932.

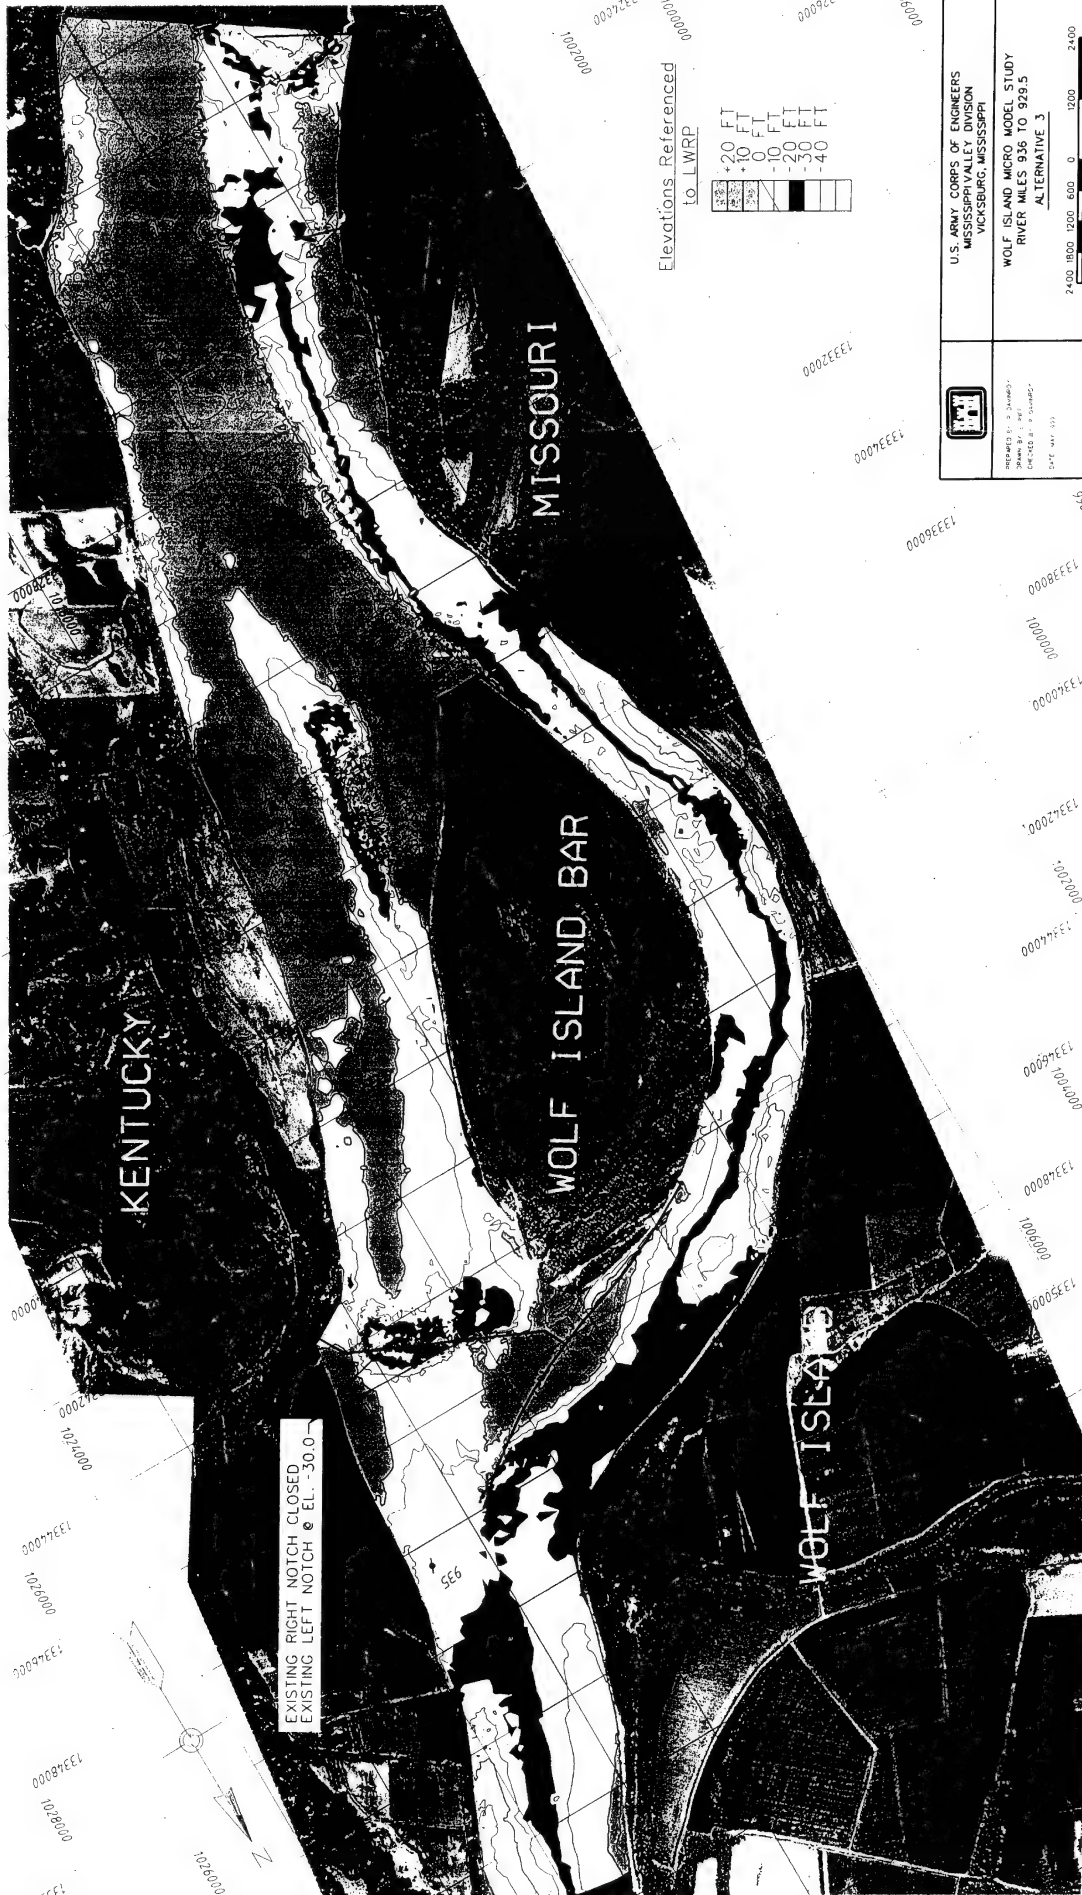
20

Elevations Referenced
to LWRP
